# EFFECT OF X-RAYS ON THE MECHANICAL PROPERTIES OF ALUMINIZED FEP TEFLON®

James R. Gaier  
NASA Lewis Research Center, Cleveland, OH 44135

## ABSTRACT

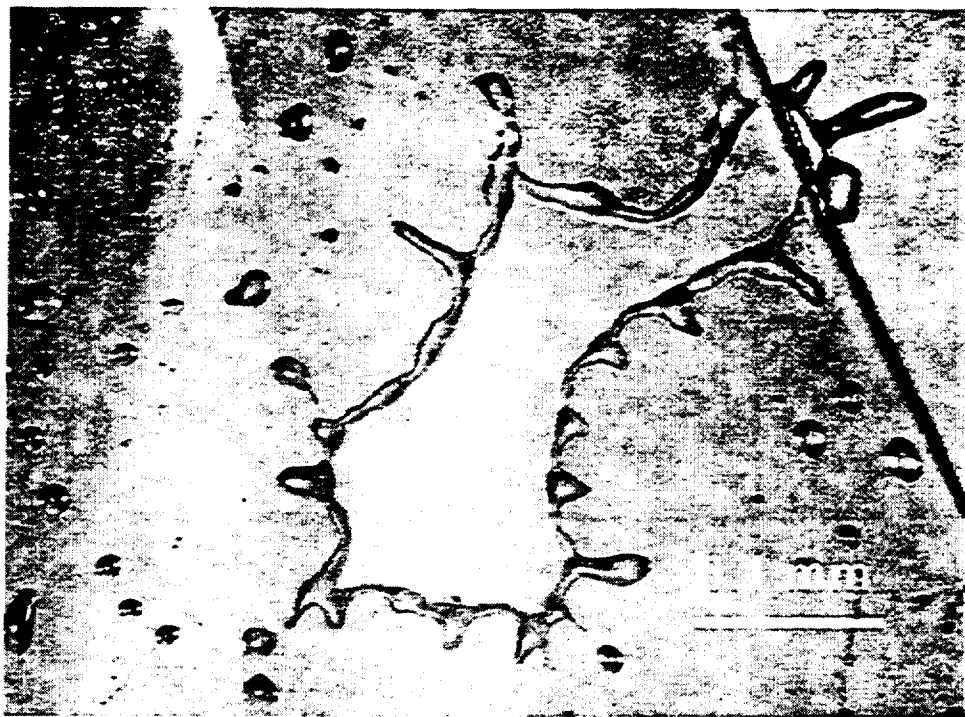
Figure 5 -- Liquid seeping from cracks in FEP induced by x-ray irradiation.
